VISUALIZATION OF SECONDARY-FLOW PHENOMENA  
IN COOLED GAS-TURBINE BLADES

SUBMITTED IN PARTIAL FULFILLMENT  
OF THE REQUIREMENTS FOR THE  
DEGREE OF NAVAL ENGINEER  
AND THE DEGREE OF  
MASTER OF SCIENCE IN MECHANICAL ENGINEERING  
At The  
MASSACHUSETTS INSTITUTE OF TECHNOLOGY  
JUNE, 1970

Mathematical models of the heat transfer in cooled gas-turbine blades have little empirical justification. If the flow phenomena that influence heat transfer could be photographed more accurate estimates of the heat transferred in a cooled gas turbine could be made.

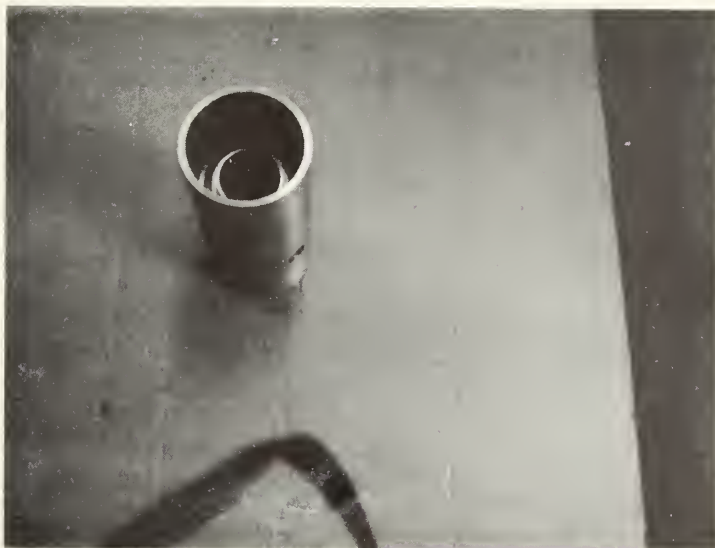
Bearing Housing With Outer Races  
Figure II-2

Next, the rotor / stator mounting assembly was built. The bearing housing, O-ring supports, bearing spacers, and spline sleeve were machined in accordance with design specifications. The outer races, bearing spacer, and retainer rings were pressed into the bearing housing. The upstream inner race and O-ring support were pressed on to the spline sleeve. The sub-assembly was inserted into the bearing-housing assembly. The inlet guide vanes were mounted on to guide-vane support plate and secured with hose clamps. The support plate was mounted on to the rotor. The downstream O-ring support and bearing inner race were pressed on to the rotor. The housing assembly

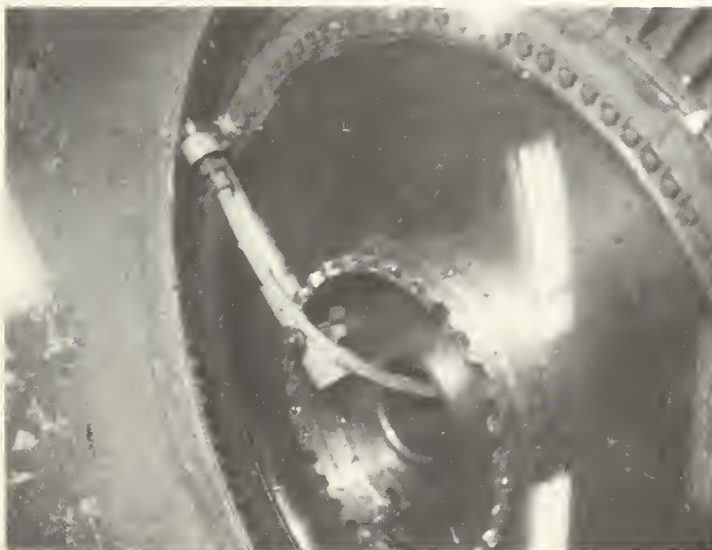
Figure III-3 shows the cavity down-stream of the rotor where the dye traces were photographed. The rotor is not

operating and the cavity is empty. This is the orientation of the camera and the light intensity employed during initial testing runs.

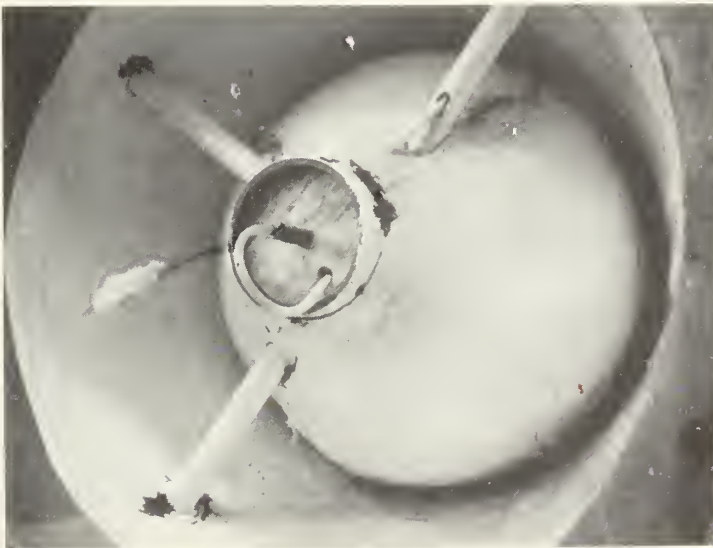
Figures III-5 and 6 illustrate better the extent of the cracks in the contraction surface. No photographs of the damage to the downstream portion of the plaster were taken.

The original contraction surface was built with a wood foundation. It was anticipated that the plaster and the epoxy sealer would prevent the water from reaching the wood and causing any distortion. Figures III-5 and 6 indicate the damage resulting from the wood swelling. The seizing of the rotor was caused by the wood in the outer annulus expanding and compressing the inlet guide vanes onto the rotor. All wood was subsequently removed and replaced by styrofoam. Styrofoam proved to be a very rigid, watertight foundation for the acceleration surfaces. No problems were experienced with the styrofoam during the second series of tests. Some of the plaster used to fair in struts and dye tubes did break off during the final tests. This, however, did not jeopardize the tests.

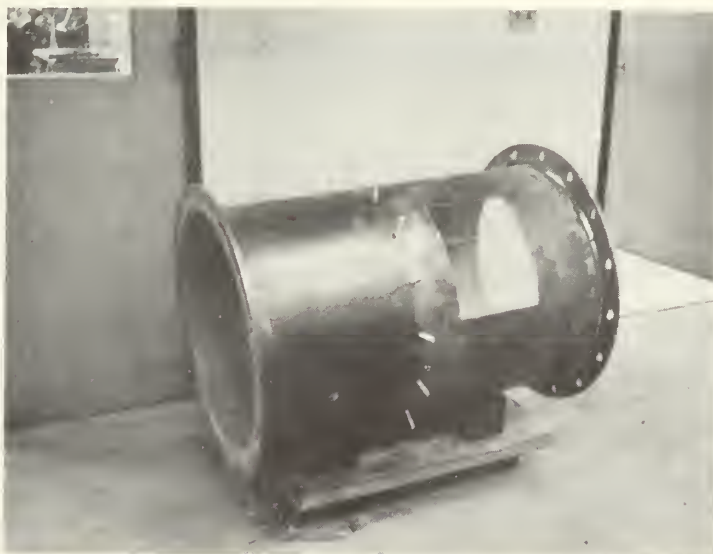
Figure B-5

The new test section made for the present experiment was fabricated from 3/16-inch rolled-steel plate. The thickness of the plate was in accordance with original tunnel design criteria. Dimensions of the section were dictated by the space remaining after modification of the tunnel and the size of the flange on the diffuser. A 9.0 inch by 12.0 inch viewing port was included in the test section to facilitate minor repairs and to monitor overall turbine operation. The longitudinal joint of the test section was welded on both sides while the 3/8 inch flanges were welded completely on the inside and tack welded only on the outside. This was in keeping with tunnel-design procedures. Non-destructive tests were not performed on the welds.
